NEW MEXICO
ENVIRONMENT DEPARTMENT

Memorandum

Subject: Pre-CERCLIS Screening Assessment of the Johnny M mine
(Grants Mining District), McKinley County, New Mexico:
Further action under CERCLA recommended

Observations from 07/26/2010 Site reconnaissance of Johnny M minesite

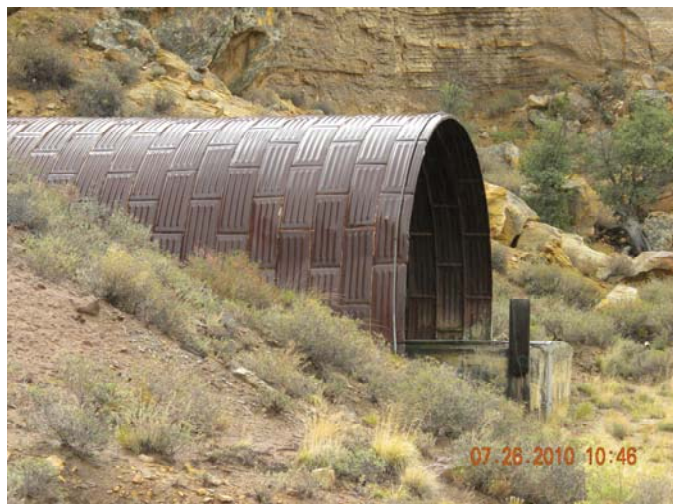
Features currently at the Johnny M minesite ("Site"), as documented during New Mexico Environment Department's ("NMED's") inspection on July 26, 2010, include a metal half-cylindrical overhang (see P1, P2 and P10), at the back of which is a partially-collapsed elevated wooden platform and a locked vault door (see P15). According to the property owner, Harry Lee, the vault now safeguards artifacts that have been collected from the Floyd Lee Ranch. Additionally, the Site includes several concrete pads (see P8, P11 and P16), several subterranean cylindrical metal vaults and vertical pipes—most of which contain pipes (see P14) and some of which are only partially covered with metal plates (see P4 and P5)—and a fenced former substation with 5 presumed former transformer pads (see P7). The Site is located within a steep-sided valley (see P10 and P12) that broadens considerably toward its mouth, opening into the broader valley of San Mateo Creek ("SMC;" see P13). A predominantly straight drainage, in which concrete debris (see P8), pipes, and wires are exposed, trends southeastward in the direction of SMC; this may be the former dewatering ditch/pipe that is discussed below. The floor of the valley is mostly very flat and appears to

P1: View of vault to southwest from access road

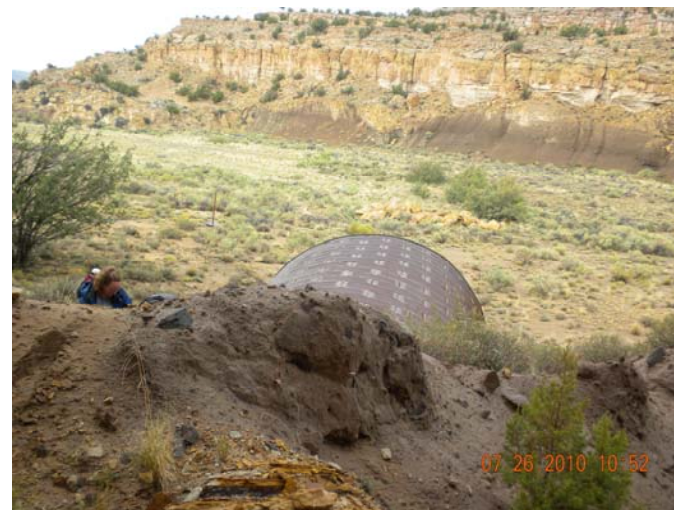
P2: View to west side of valley from above vault overhang

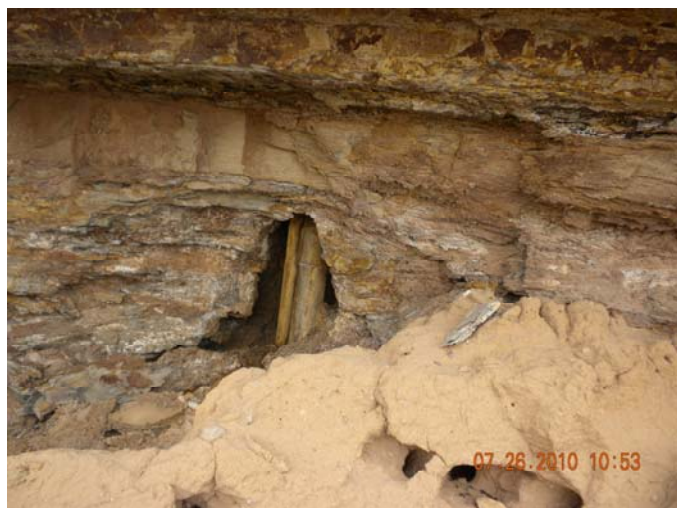
P3: View to east of utilities entering vault below through escarpment

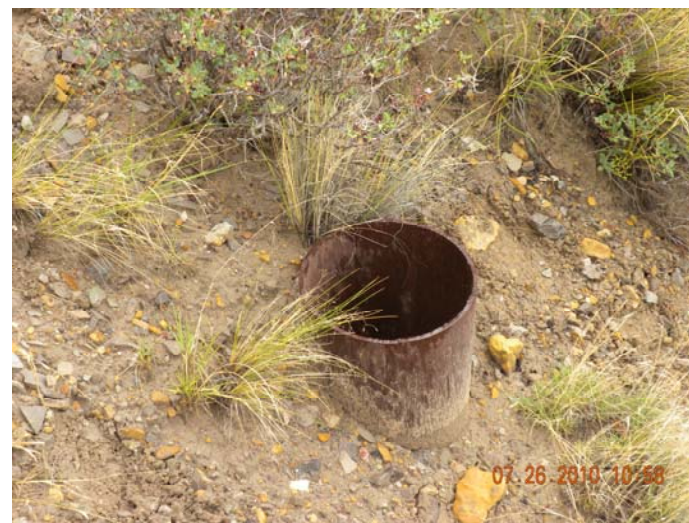
P4: Metal pipe, possibly containing well

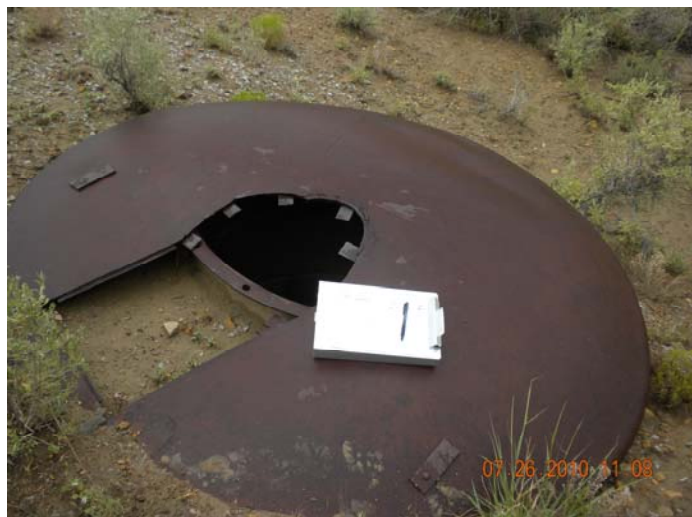
P5: ~5-ft deep vault with piping

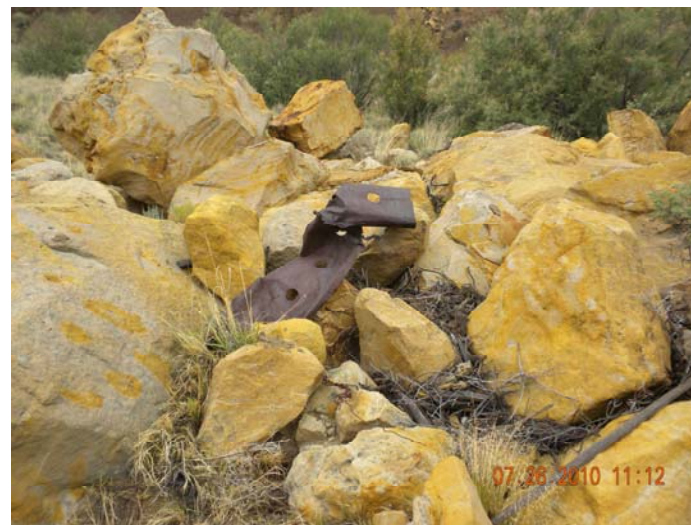
have been graded. Two of the concrete pads include large diameter circular features, one of which has a protruding open pipe (see P11); these circular features may be the locations of the former mine shafts, and the protruding pipe may be the location of a ground water monitoring access point that is referenced in NMED documents from the time of Site reclamation. There are abundant pieces of thin wire exposed in the soil around the Site, and one blasting cap was identified by a member of the State inspection team. Additionally there are small amounts of iron and wood debris scattered around the Site (see P6).

P6: Metal debris among sandstone boulders

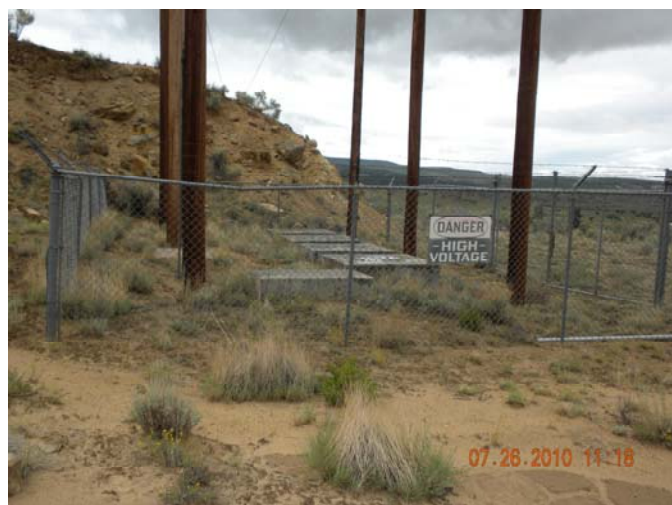
P7: Former substation location with 5 transformer pads

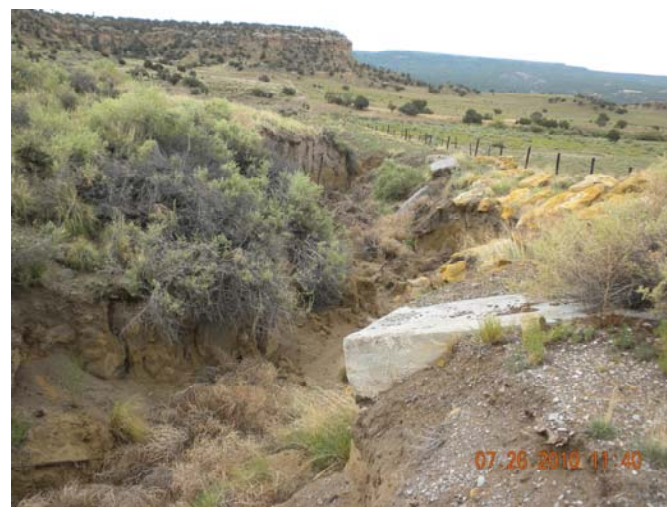
P8: View to south of concrete slab along drainage

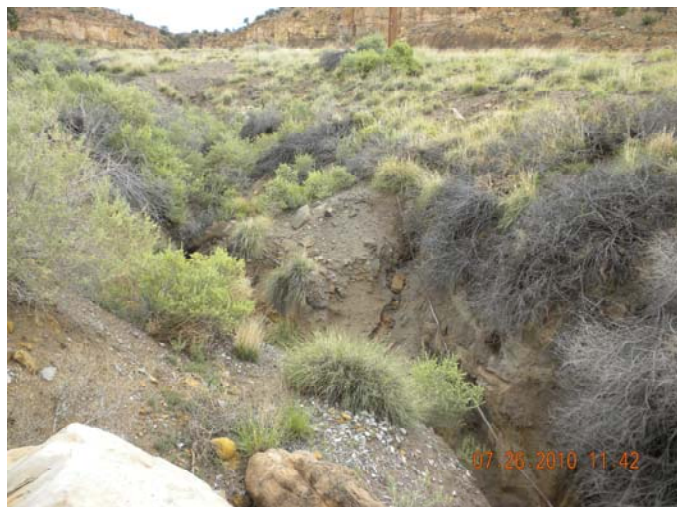
P9: View to north along drainage towards head of valley and minesite

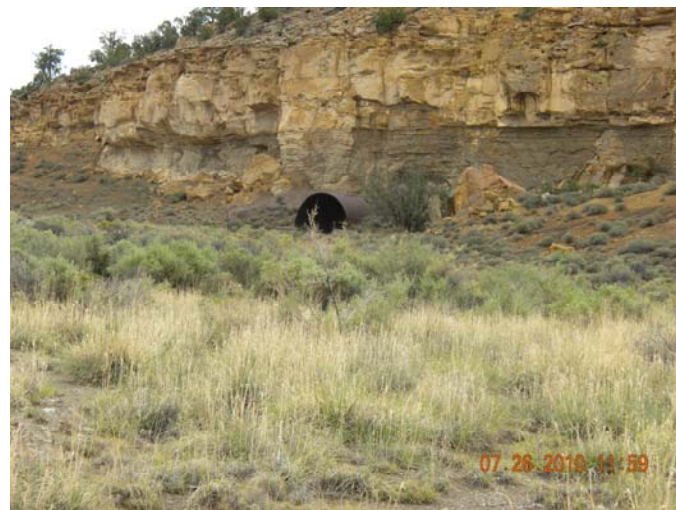
P10: View of vault entrance toward northeast

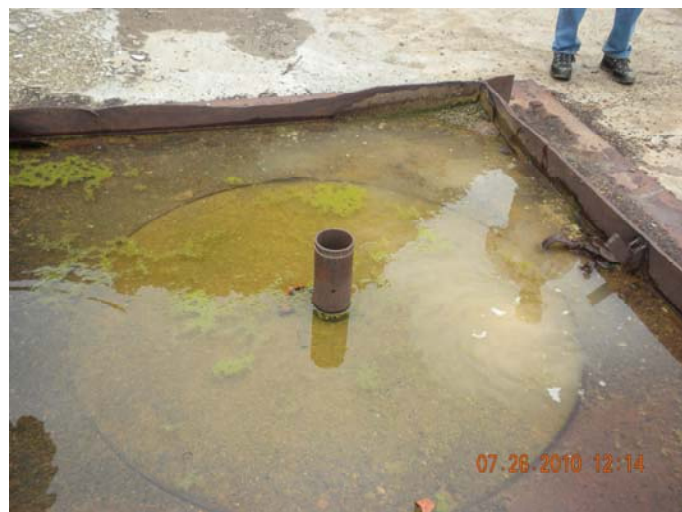
P11: Concrete pad with circular concrete plug and protruding pipe

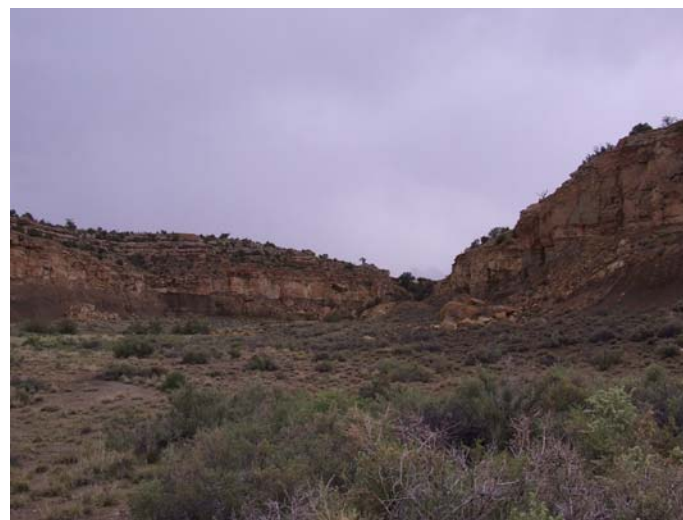
P12: View north toward head of valley

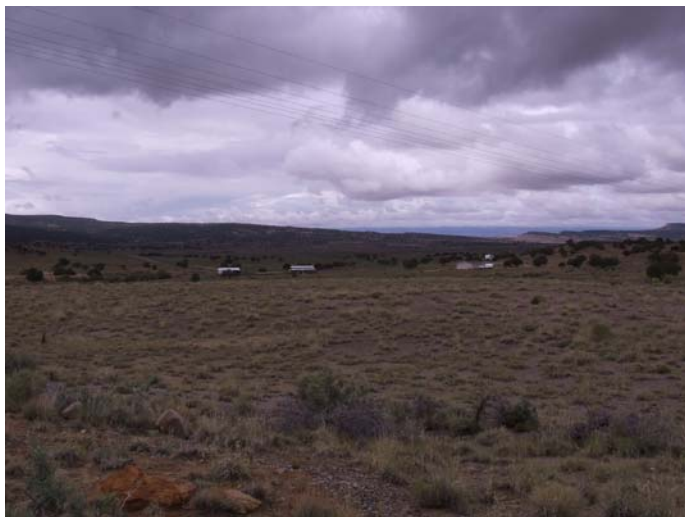
P13: View south from mouth of valley toward San Mateo Creek

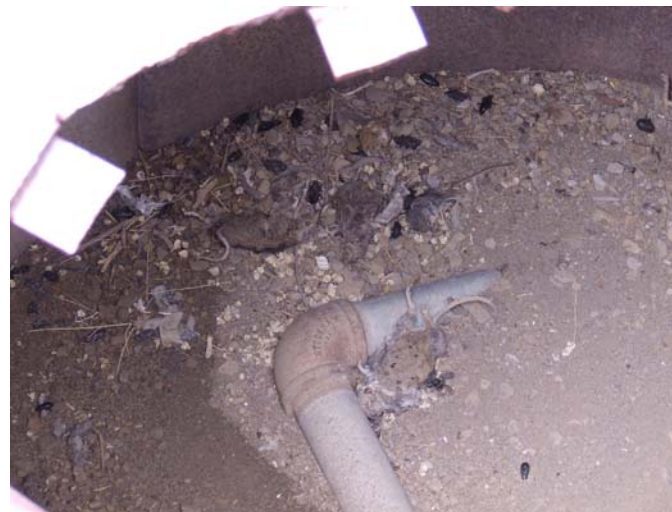
P14: View into a metal circular vault

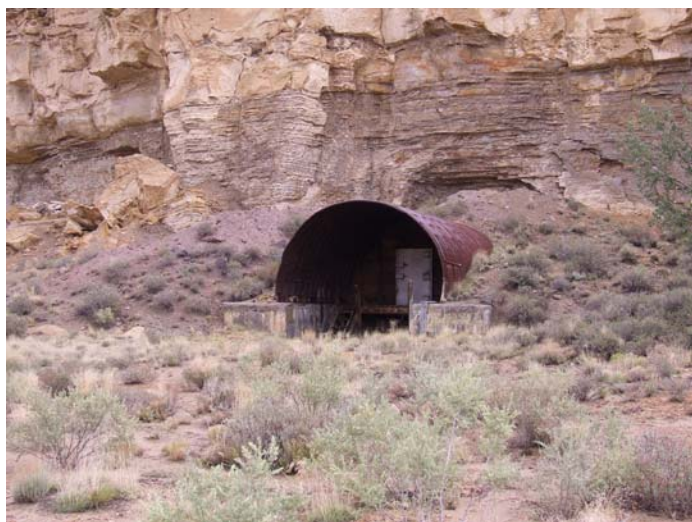
P15: View into metal overhang showing platform and vault door

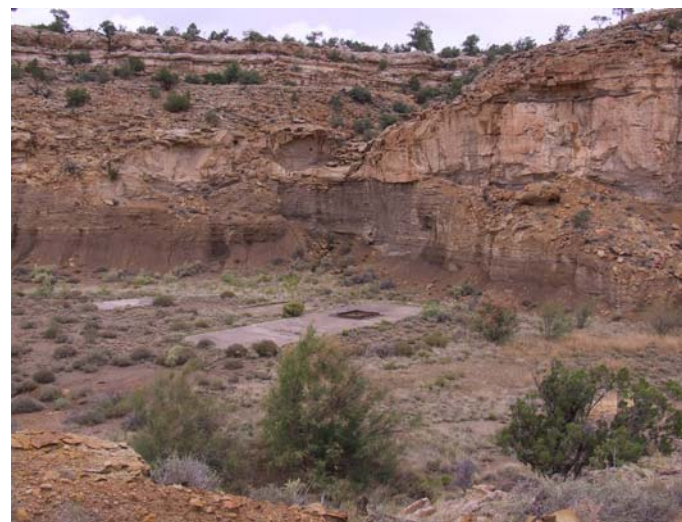
P16: View toward southeast of valley
